14. ABSTRACT THIS PROGRESS REPORT DEFINES ROOT CAUSES OF THE DRIVELINE AND POWERPLANT COMPONENT FAILURES OF LMTV VEHICLES. THESE FAILURES HAVE RESULTED IN A SAFETY OF USE MESSAGE RESTRICTING OPERATING SPEEDS TO 30 MPH MAXIMUM. POSSIBLE CORRECTIVE ACTIONS ARE DISCUSSED.

***PROGRESS REPORT
OF
LMTV FLYWHEEL HOUSING
AND
DRIVELINE
FAILURE INVESTIGATION***

Contract No. DAAE07-98-C-M012

***Hayes Hobolth
17 August 1998***

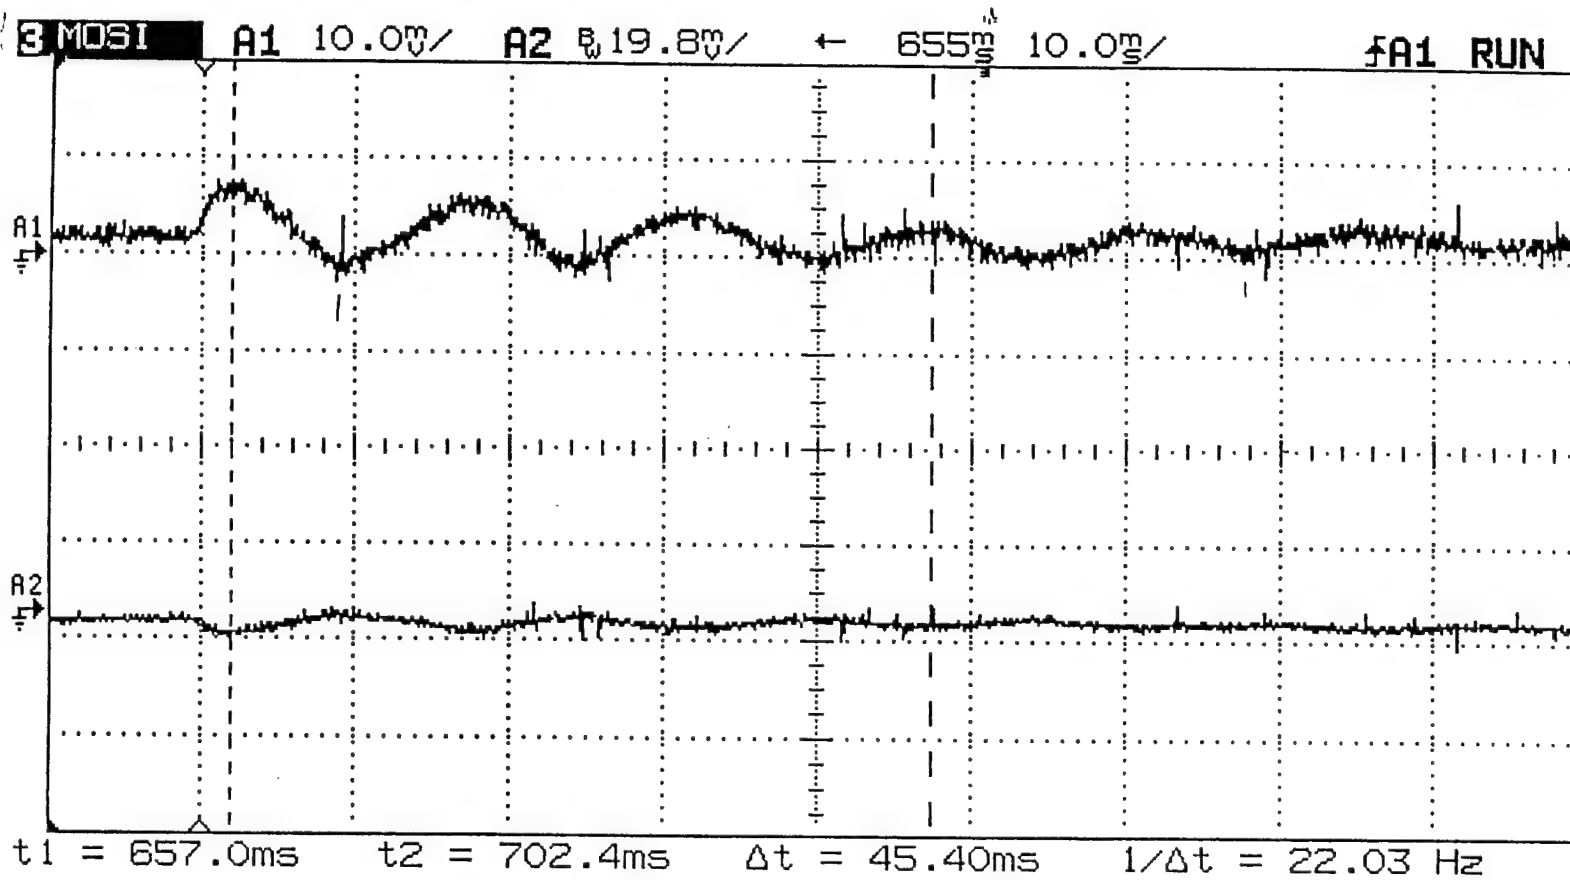
Impact Test of Natural Frequency 65-68 Hz (Original - 47.6 Hz)

Preliminary Results of First Mode Vertical Bending

- Impact test agrees with Caterpillar projection for ductile iron and increased section.
- Speed sweeps do not show a clearly defined resonance.
- Probing for the characteristic first mode vertical bending suggest that the new bending mode may be critically damped

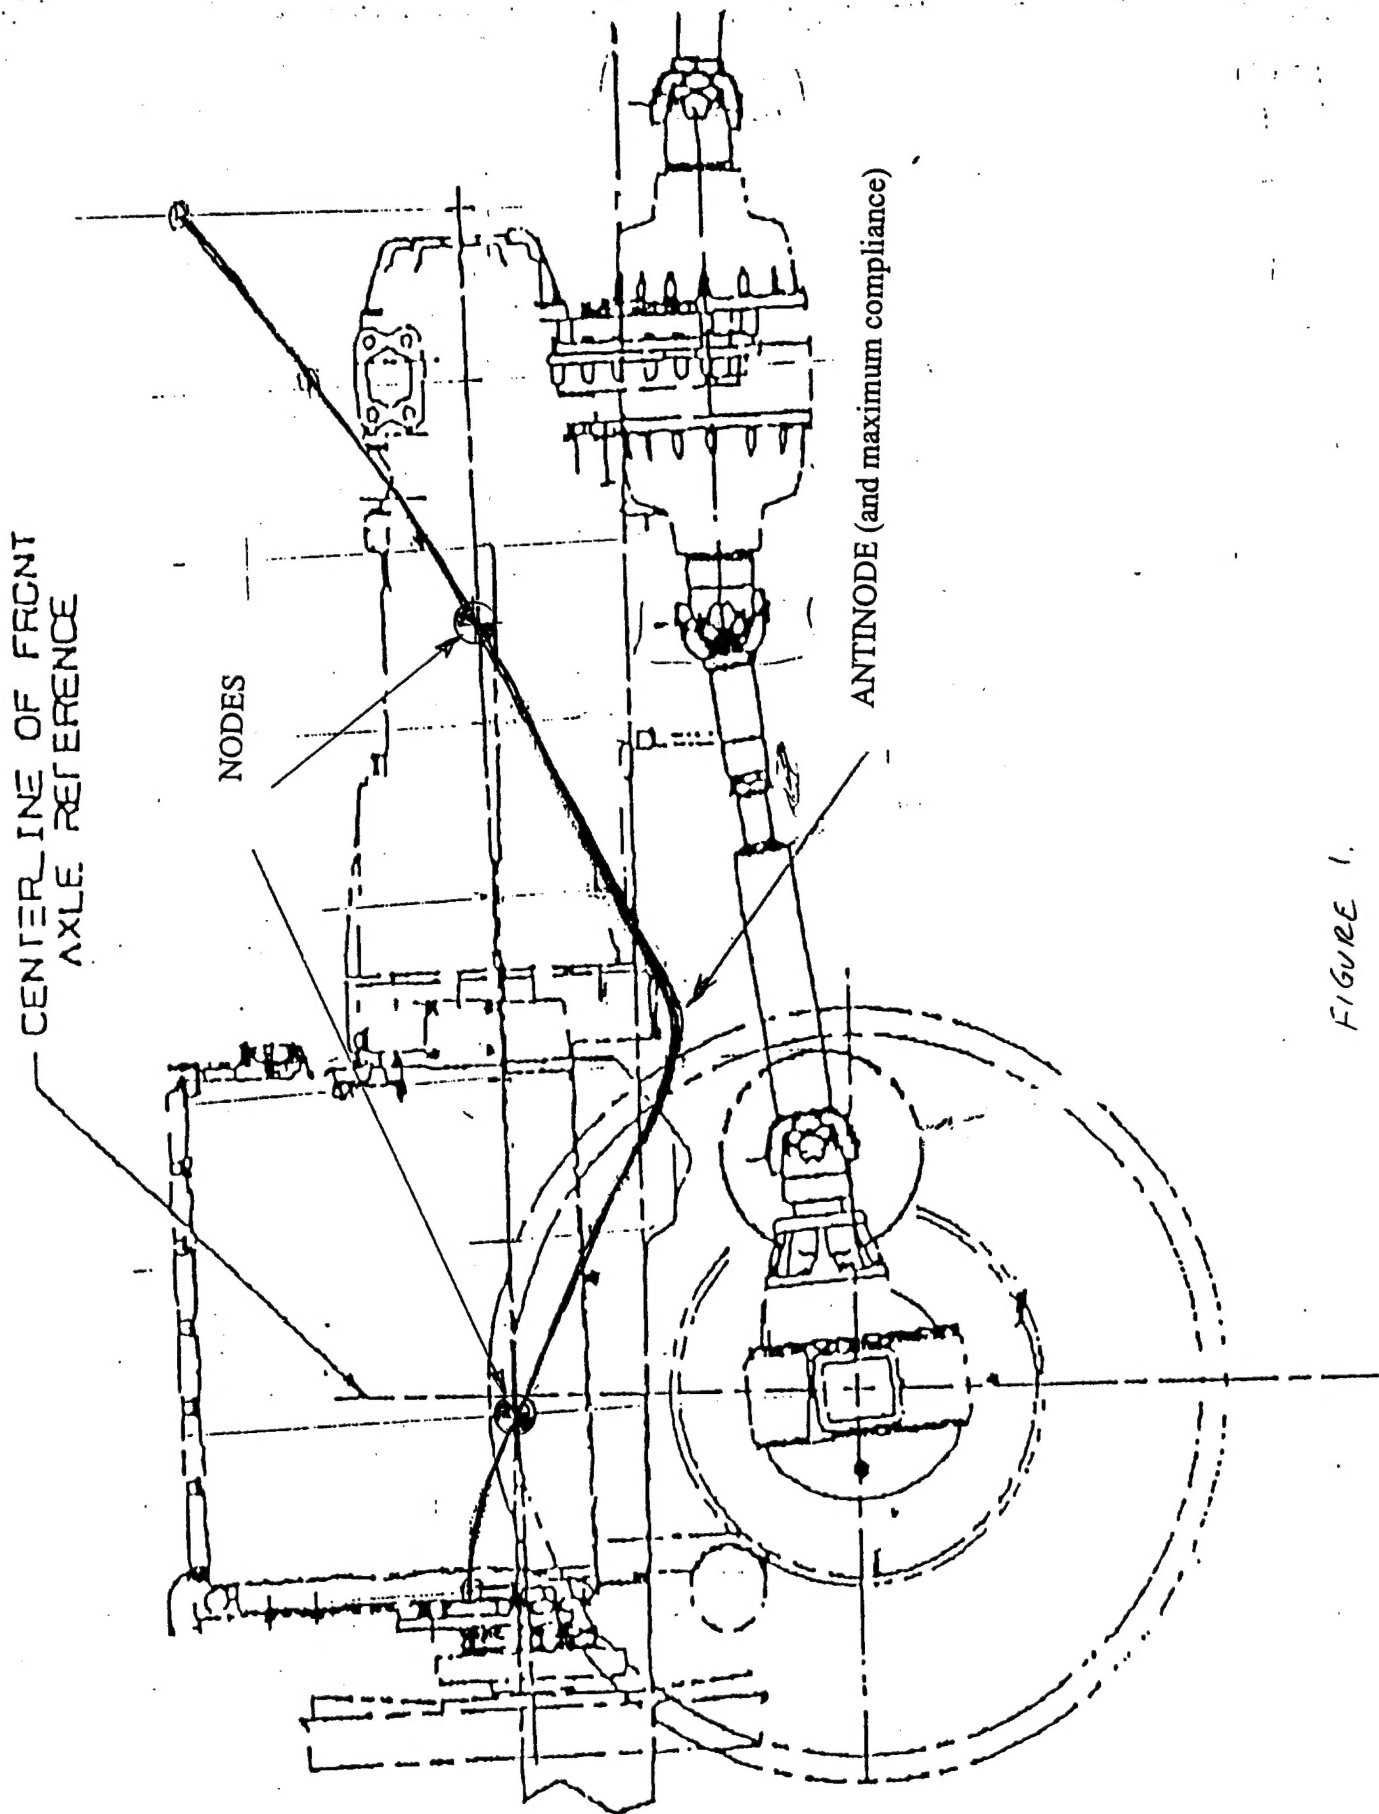
FIGURE 1.

An important relationship is shown in Figure 1, which is a mode shape of the vertical bending mode of the resonant response at its peak excited by the an unbalance at the transfer case output. The dynamic first order vertical velocity was probed at 10 inch increments along the length of the powertrain and is plotted on a side view. It clearly shows that the elastic energy is stored in the deformation of the flywheel housing.

FIRST MODE VERTICAL BENDING @ 47.6 HZ
